Item #13C:
Village Trustee Marshall
Three Lake Drive Storm Sewer Culvert - Update

Subject: Water Conveyance Modification/Pond Sediment Removal

Re: The Lakes of Long Grove Outlet Structure Investigation

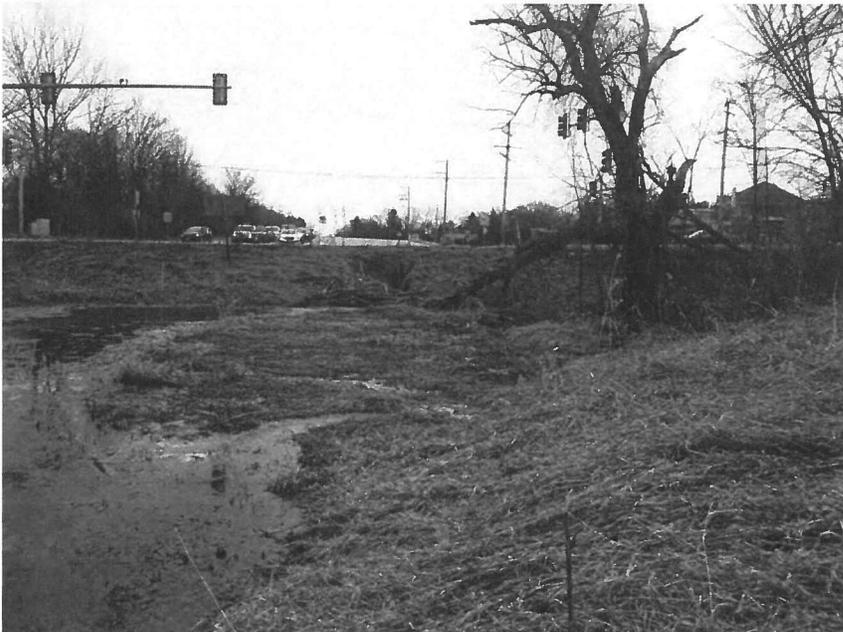
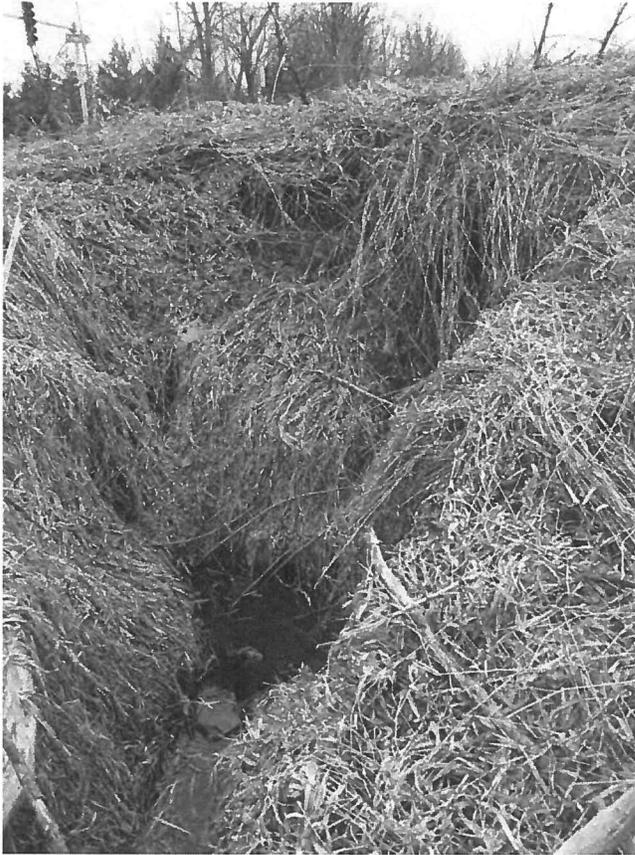
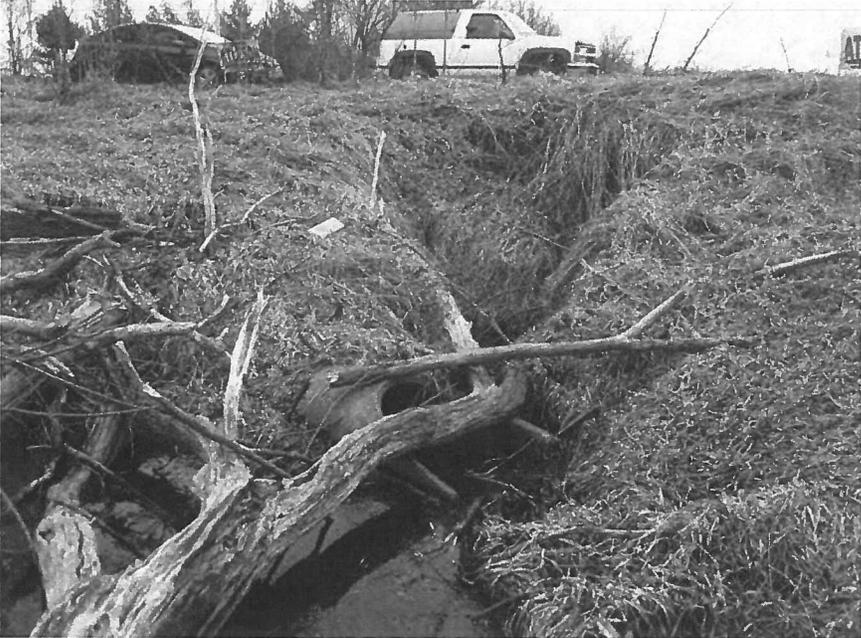
State Route 83 Drainage - The drainage inlet beneath St. Rt. 83 was observed to be in poor to very poor condition. Woody debris from fallen trees was scattered around the inlet. A significant area of erosion, potentially caused by a broken drainage culvert was observed in the St. Rt. 83 embankment. This erosion may affect the integrity of the roadway if not addressed soon. The woody debris and poor condition of the inlet structure appeared to be backing up water at the base of the East Basin berm, and had created a wetland with standing water at the time of our visit. Wetland delineation flags were observed around the area at the base of the berm. Photographs of the St. Rt. 83 inlet pipe are included in Exhibit E.

The storm water inlet under St. Rt. 83 should be repaired as soon as possible. BCE has contacts with the Lake County Department of Transportation (DOT), and will notify them of the

conditions we observed. ILM encourages the Village of Long Grove to also make the Lake County DOT aware of this condition so that repair work can begin as soon as possible, so the St. Rt. 83 road embankment is not compromised, and water can flow away from the base of the berm when discharged.

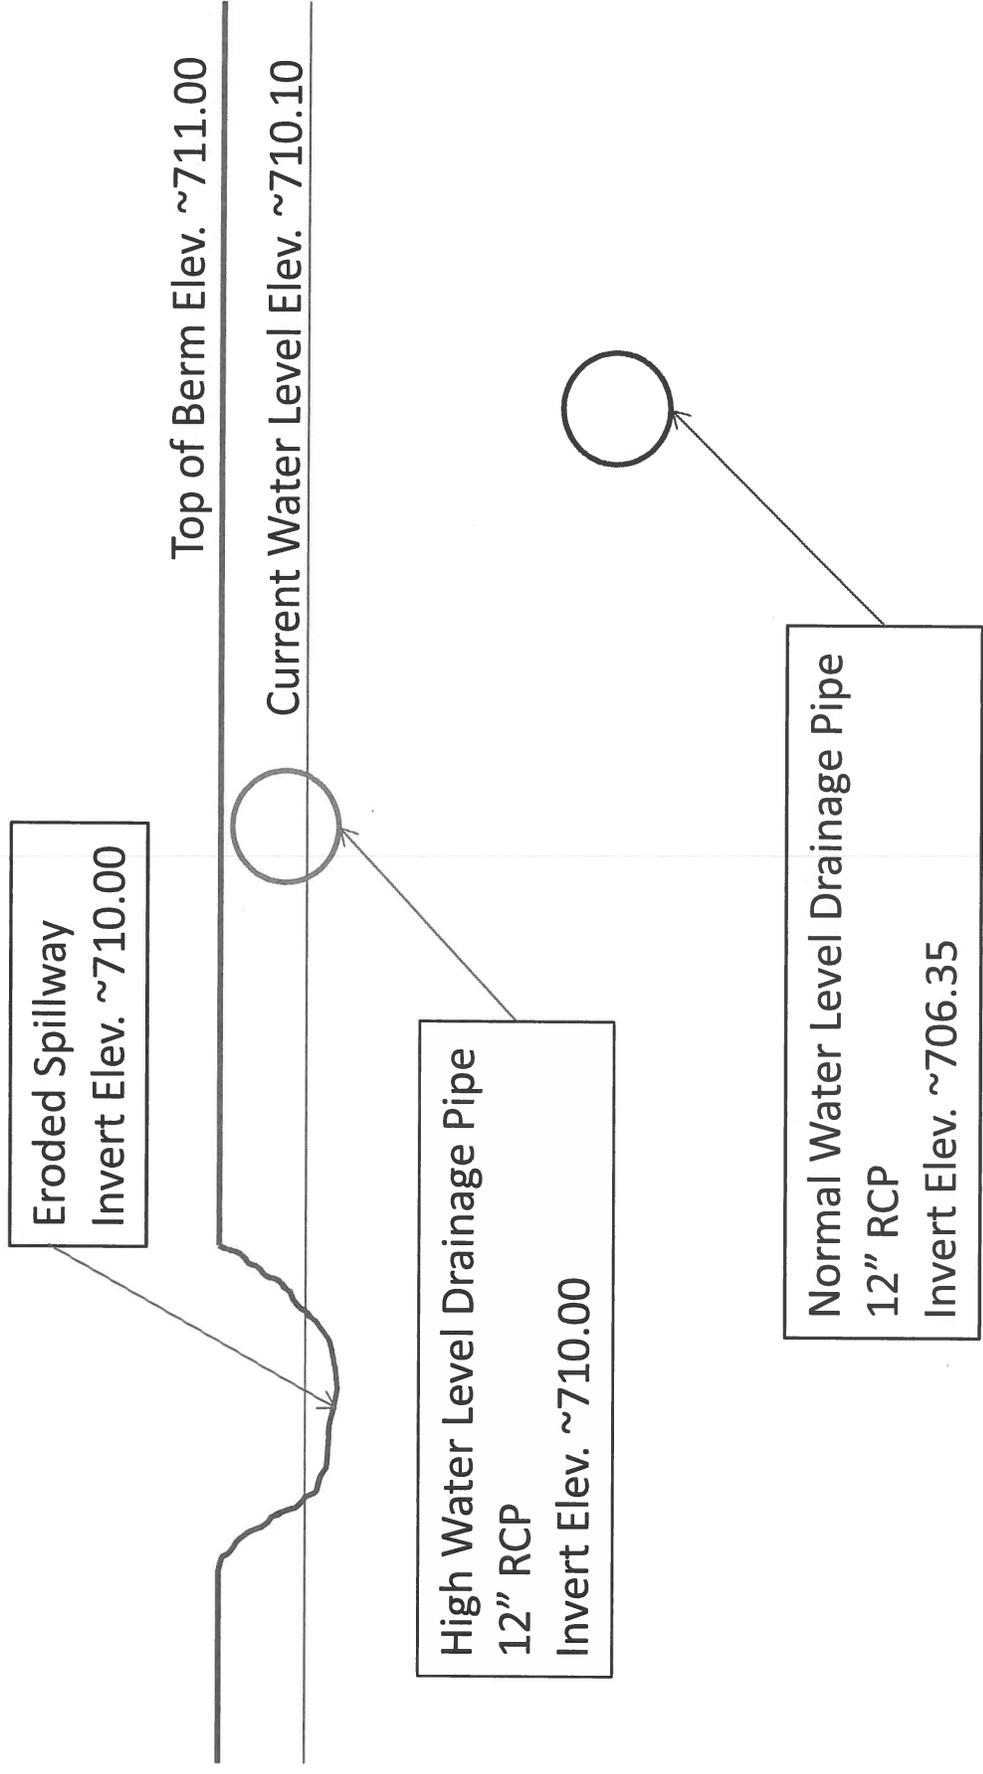
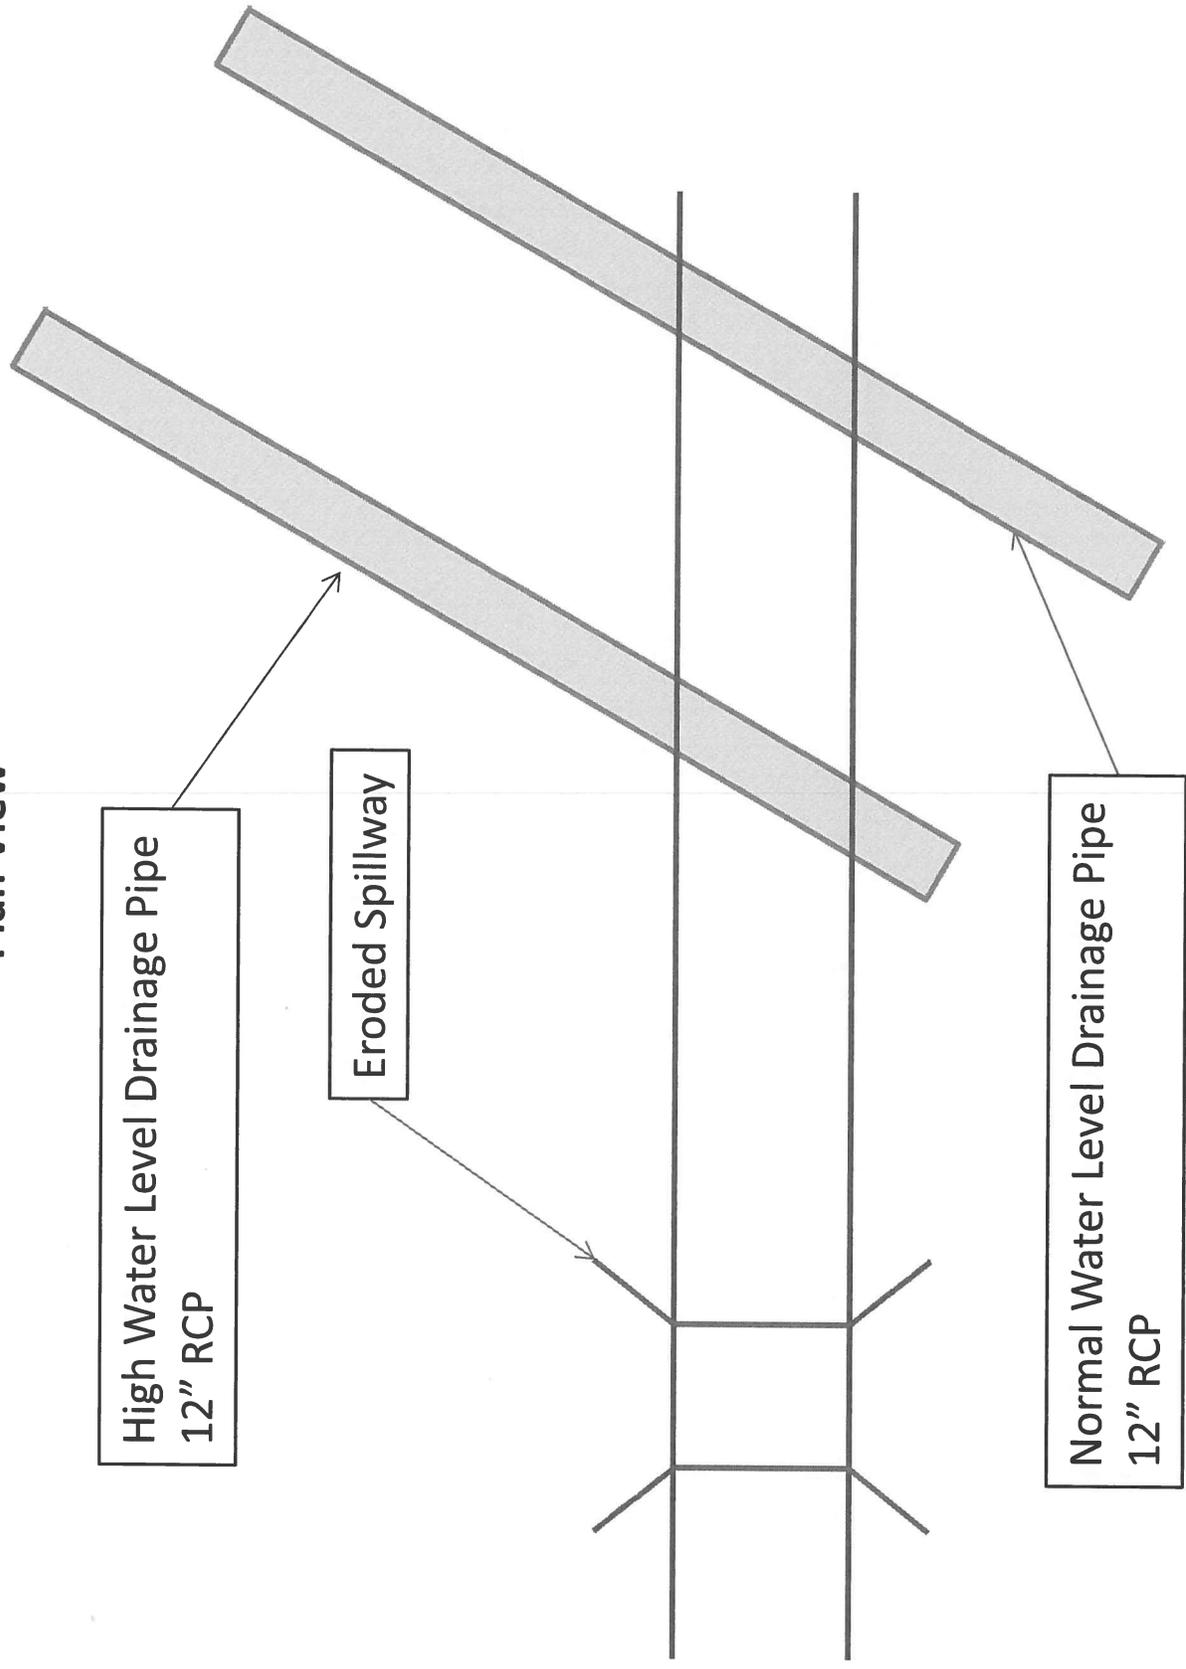
Levee/Berm Condition – The levee, or berm on the north end of the East Basin is in poor to very poor condition. Seepage was evident along the entire base of the berm. Woody vegetation and trees were observed to be growing on top of and on the embankments. Numerous animal burrows were observed in the berm. Approximately halfway along the top of the berm, an eroded spillway was observed. The spillway did not appear to be a designed structure; rather, it appeared to have formed over time as a result of erosion along the top of the berm. A photo of the eroded spillway is included as Exhibit B. The water level on March 31, 2014 was very near the top of the berm. The eroded spillway was serving as the primary water control structure.

High Water Level Drainage – The Record Drawings show a concrete weir detail as the proposed high water overflow structure. During our site visit, a weir structure was not observed. Instead, an approximately 12-inch reinforced concrete pipe at the estimated high water level was identified. The inlet of the pipe was not protected with a grate, and was plugged with woody debris and leaves. A photograph of the high water level drainage inlet is included as Exhibit C. The outlet of the high water level drainage pipe did not have an outfall apron. While inspecting the outlet of the pipe it was observed that water was seeping around the outside of the pipe, and was not flowing through the inside of the pipe. When debris was manually cleared from the pipe inlet, water began draining freely through the high water level drainage pipe, indicating that this pipe is not plugged internally.

Normal Water Level Drainage – A second, approximately 12-inch reinforced concrete pipe that appeared to be the primary NWL outlet structure was observed approximately 50-feet east of the high water level drainage pipe. There was no drainage present inside, or along the outside of this pipe. The spillway apron at the base of the pipe had been pulled away from the rest of the pipe by approximately 3-inches. A photograph of the outlet of the NWL pipe is included as Exhibit D. Based on the notes on the Record Drawing, the inlet of the NWL outlet pipe is approximately 4.5-feet below the current water surface.

High Water Level Drainage Pipe
12" RCP

Eroded Spillway

Normal Water Level Drainage Pipe
12" RCP

The first step for in addressing the drainage pipe repairs is to identify the source and location of the blockage in the NWL drainage pipe which drains toward St. Rt. 83. The source of the blockage can be determined by sending a camera up the drainage pipe. The camera will allow us to determine the condition of the pipe, the location of the lower end of the blockage in the pipe, and potentially the cause of the blockage. Having this information will allow us to determine if the blockage is located within the berm, or beyond the berm, beneath the water. The cost to send a camera up the pipe is \$550.

Once the location of the NWL drain blockage is known, repair work can begin. If the blockage is determined to be beneath the water, and the pipe is in good condition, ILM proposes that an excavator be brought in to try breaking off the plugged area of the pipe in the water, allowing water to gain entry into the pipe. The excavator would work to clear debris from the pipe until the water level reaches the NWL. Once the NWL is achieved, the broken pipe would be repaired, and a grated inlet structure would be installed. The existing eroded spillway would be repaired with gravel, clay, and geotextile, to prevent further erosion.

If the camera investigation indicates that the pipe is in poor condition, or the plug is within the berm, the effort to repair the drainage outlet is significantly increased. Pumps will be necessary to drain the lake down to, or below the NWL. Once the water level is at or below the NWL, the existing drain pipe can be excavated out of the berm, and a new drain pipe, inlet, and outfall apron can be installed. The existing eroded spillway would be repaired with gravel, clay, and geotextile, to prevent further erosion. The cost of this repair work is not known at this time due to the potential permitting, design, and construction uncertainties.

All woody vegetation that is currently growing on the berm should be cut and removed, to reduce the risk of berm failure. The roots of woody vegetation create flow pathways for water to pass through the berm, causing seepage and loss of structural integrity.
