Re: Robert Parker Coffin Road Bridge  
IDOT Structure Number: 049-7150

As per your request, on Wednesday, April 3, 2013 I met you at the above referenced structure and conducted a Routine NBIS Inspection of the bridge.

VILLAGE OF LONG GROVE – ROBERT PARKER COFFIN ROAD BRIDGE

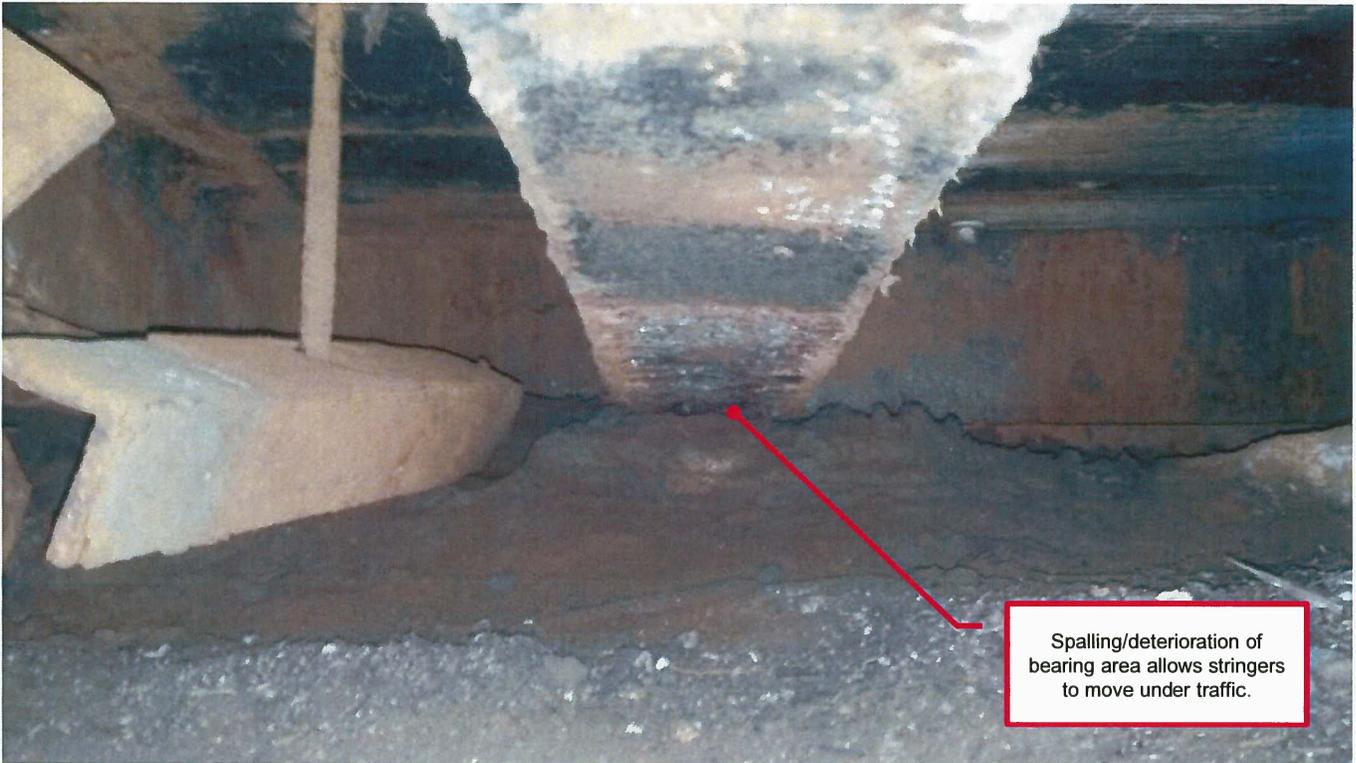
1. A section of the armoring angle is missing on the approach end of the east abutment.
2. As vehicles cross the structure, the east end of the bridge deflects downward by approximately two (2) inches.
3. Deterioration and spalling of the limestone abutments continues to advance. Movement of the east end of the bridge is due to spalling of the bearing area.
4. Scour has undermined a section of the east abutment.

SPALLING IN THE BEARING AREA FOR STEEL STRINGERS – EAST ABUTMENT

1. The missing section of armoring steel should be replaced to avoid puncturing of motorist's tires.
2. The movement of the structure observed at the east abutment is not **currently** a serious structural problem. However, the abutments will continue to deteriorate and spall eventually necessitating significant repair or closure of the bridge. Additional steel bearing plates can be placed under the bearings at this time to reduce or eliminate movement of the bridge.

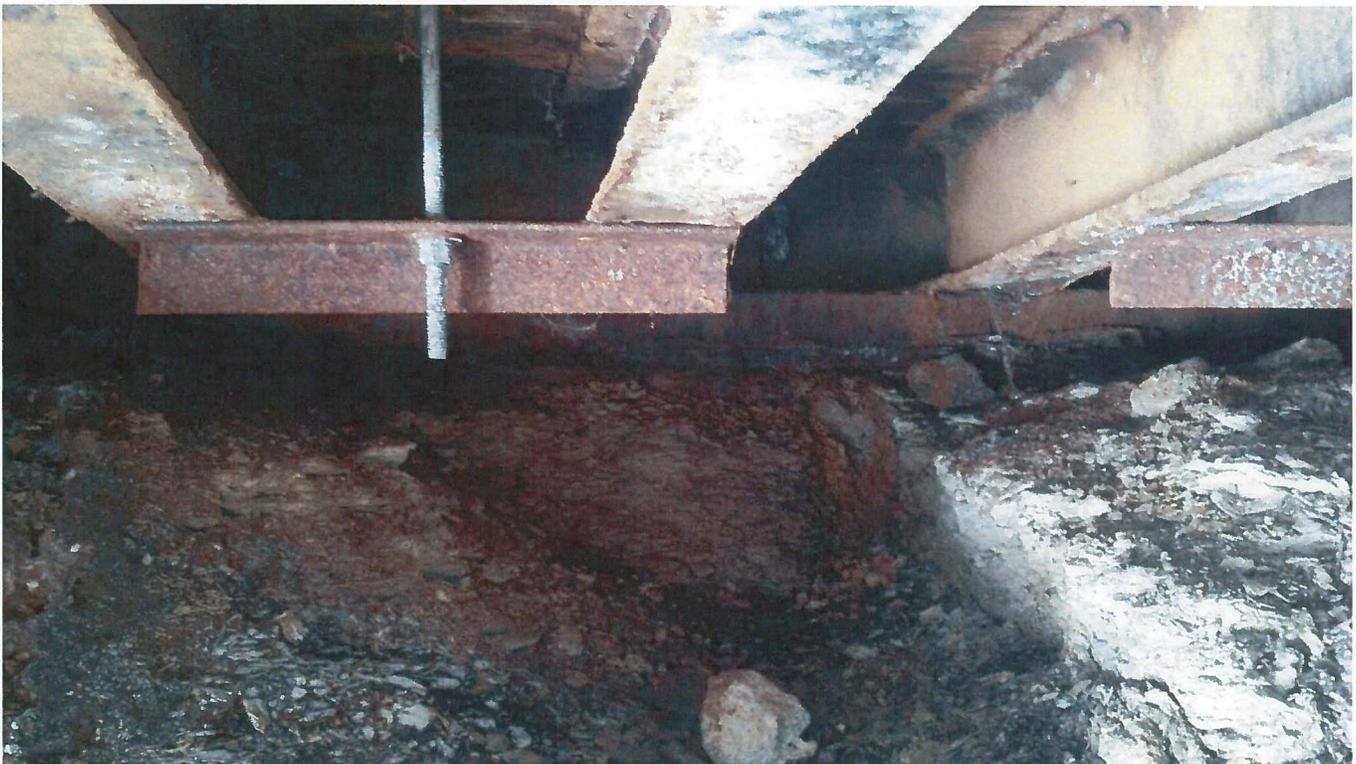
SPALLING IN THE BEARING AREA FOR STEEL STRINGERS – WEST ABUTMENT

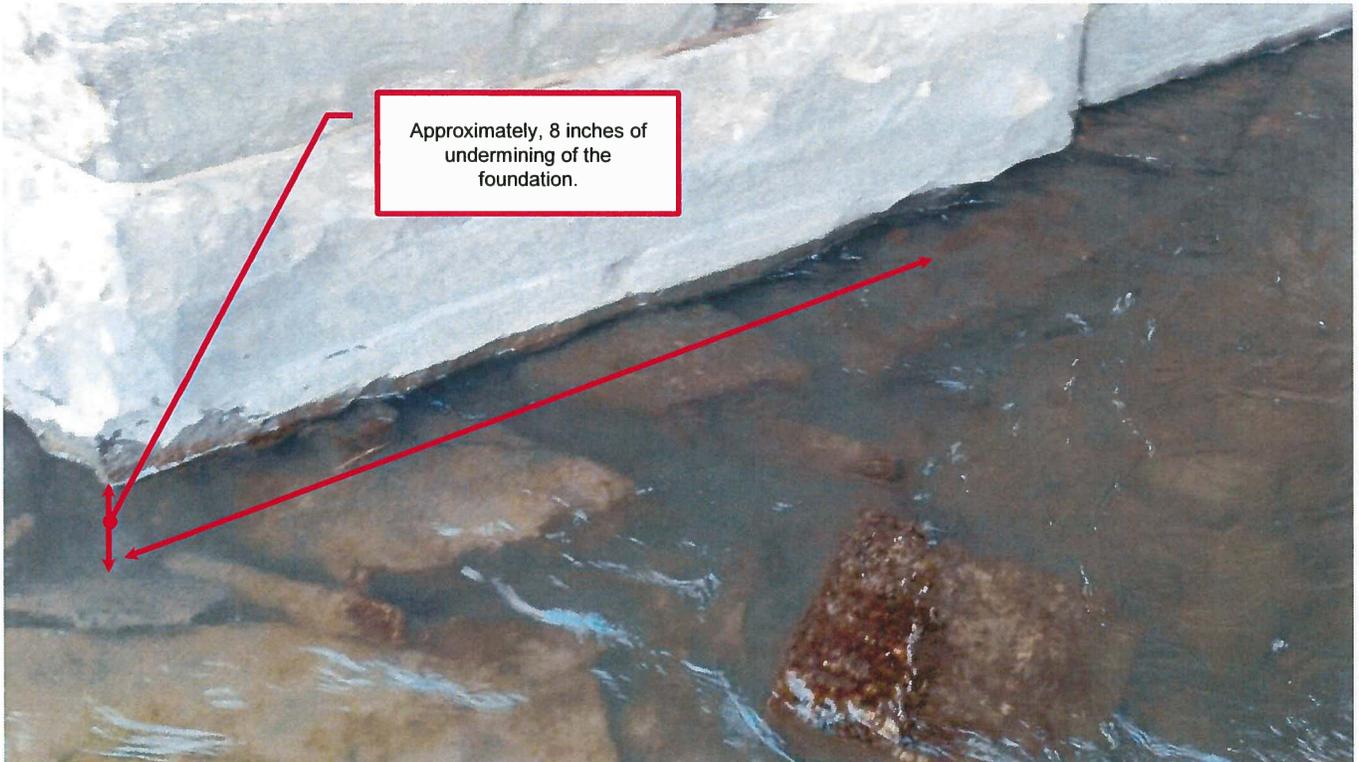
UNDERMINING AT THE NORTH END OF THE EAST ABUTMENT

3. The scouring and undermining present at the east abutment should be stabilized immediately. I recommend that the undermined section of the abutment be dewatered, a lean concrete mix be pumped under the abutment and rip rap be placed in front of the abutment to prevent further scouring.
4. The abutments should be inspected on a regular basis to avoid any serious deterioration going undetected. I recommend the abutments be inspected on a monthly basis until such time as the bridge is either closed or replaced.
