Re: Robert Parker Coffin Road Bridge  
IDOT Structure Number: 049-7150

VILLAGE OF LONG GROVE – ROBERT PARKER COFFIN ROAD BRIDGE

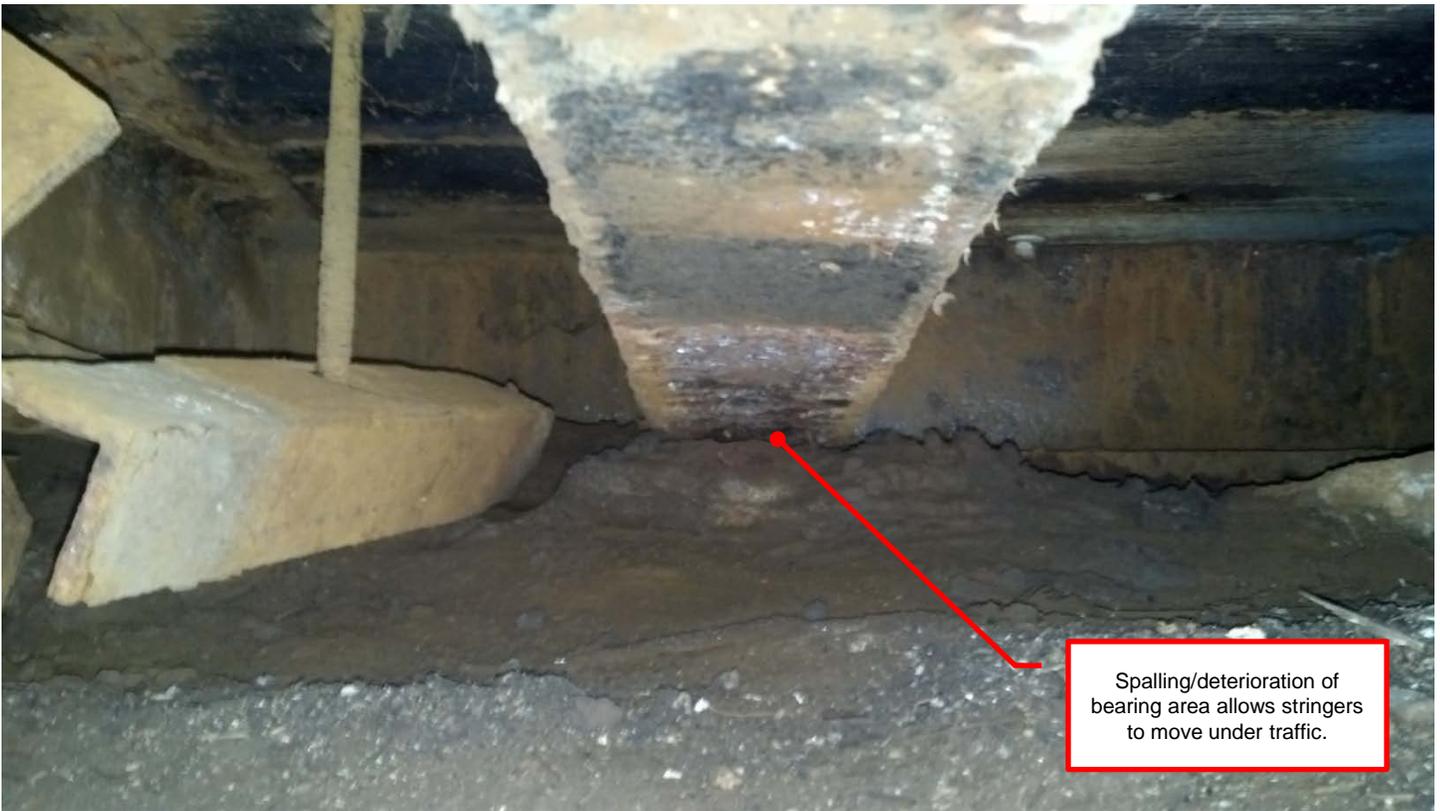
1. A section of the armoring angle is missing on the approach end of the east abutment.
2. As vehicles cross the structure, the east end of the bridge deflects downward by approximately two (2) inches.
3. Deterioration and spalling of the limestone abutments continues to advance. Movement of the east end of the bridge is due to spalling of the bearing area.
4. Scour has undermined a section of the east abutment.

SPALLING IN THE BEARING AREA FOR STEEL STRINGERS – EAST ABUTMENT

1. The missing section of armoring steel should be replaced to avoid puncturing of motorist's tires.
2. The movement of the structure observed at the east abutment is not **currently** a serious structural problem. However, the abutments will continue to deteriorate and spall eventually necessitating significant repair or closure of the bridge. Additional steel bearing plates can be placed under the bearings at this time to reduce or eliminate movement of the bridge.

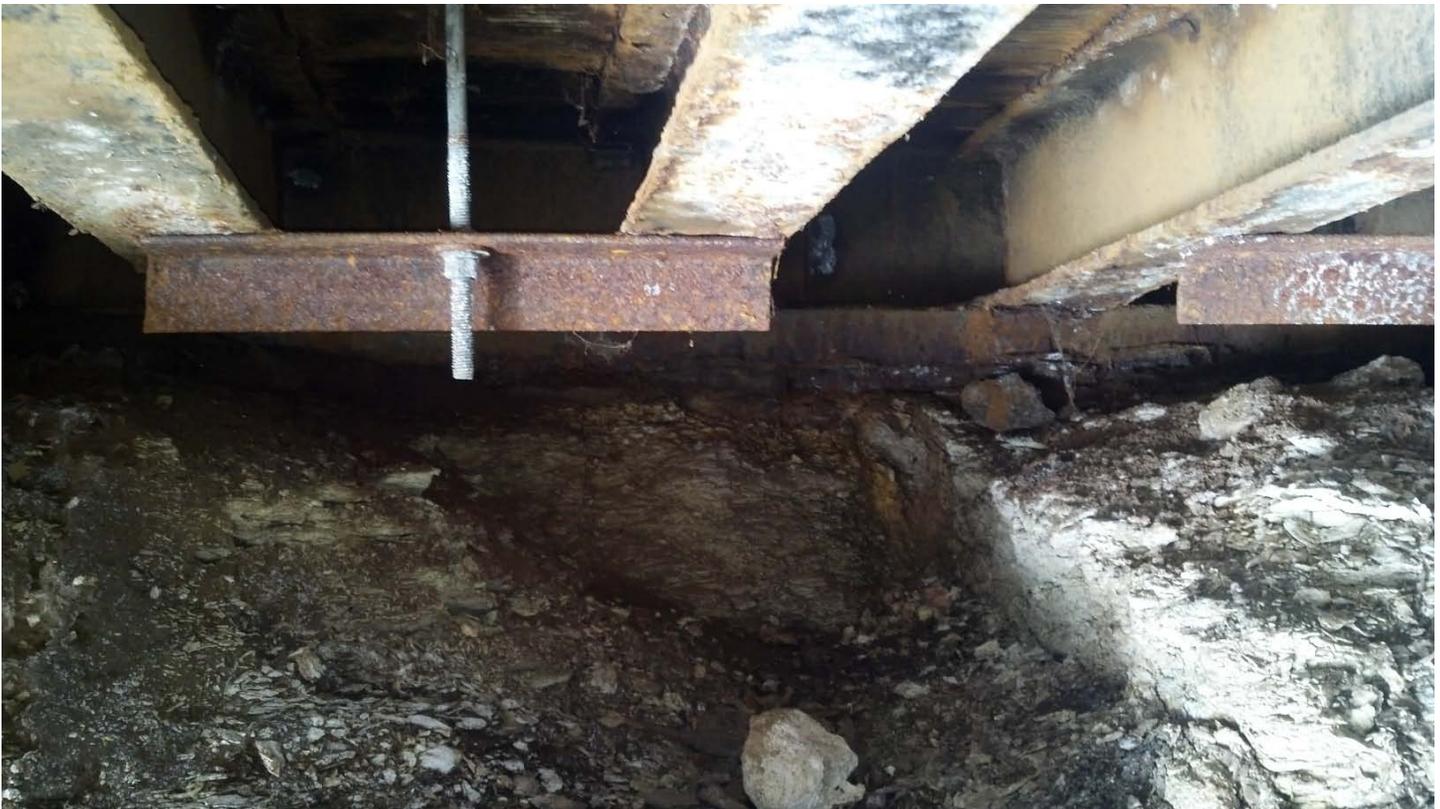
SPALLING IN THE BEARING AREA FOR STEEL STRINGERS – WEST ABUTMENT

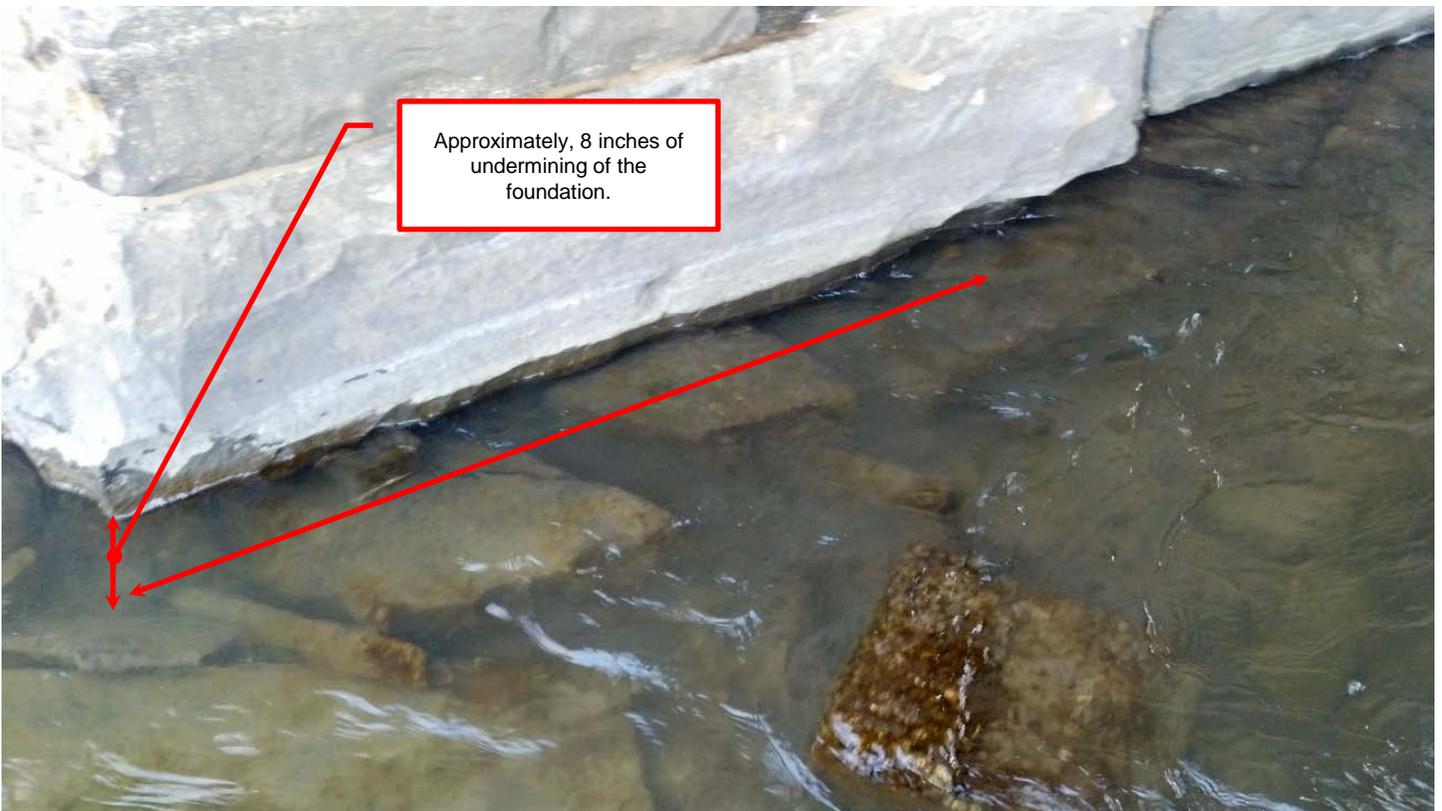
UNDERMINING AT THE NORTH END OF THE EAST ABUTMENT

3. The scouring and undermining present at the east abutment should be stabilized immediately. I recommend that the undermined section of the abutment be dewatered, a lean concrete mix be pumped under the abutment and rip rap be placed in front of the abutment to prevent further scouring.
4. The abutments should be inspected on a regular basis to avoid any serious deterioration going undetected. I recommend the abutments be inspected on a monthly basis until such time as the bridge is either closed or replaced.
