Item #8B:
Village Trustee Marshall
Three Lakes Subdivision Drainage & Lakes Management

Three Lakes Drive Drainage Improvements
Village of Long Grove

Re: The Lakes of Long Grove Outlet Structure Investigation

SEDIMENT PROBING REPORT

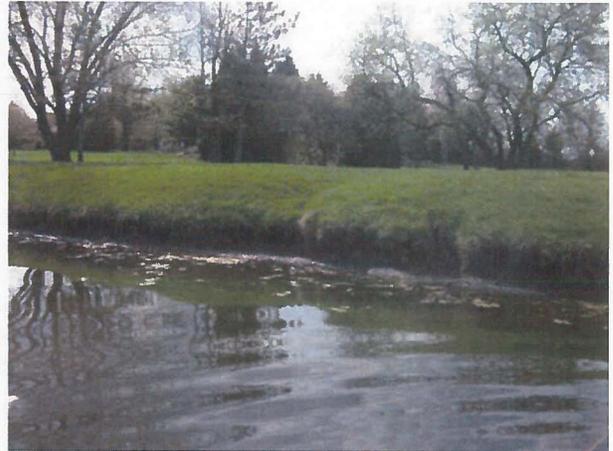
Figure 2: Shoreline erosion at East Lake.

- The main source of sediment to the lakes appears to be shoreline erosion. Mowed lawn has very shallow root systems and provides little protection to the shoreline soils. It is recommended that a native plant buffer of at least 15 – 20 feet be installed around the shoreline of all of the lakes wherever possible.

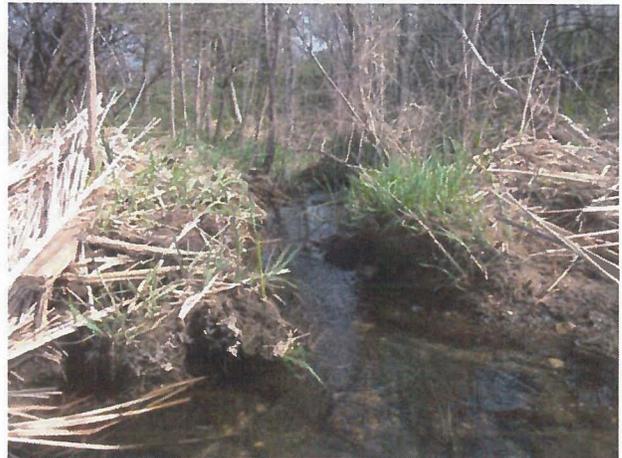
Figure 4: Outlet channel for East Lake, near Rt. 83.

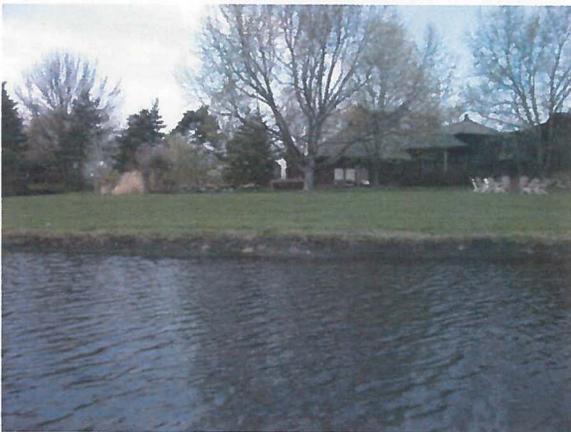
Figure 7: Shoreline erosion of Center Lake.

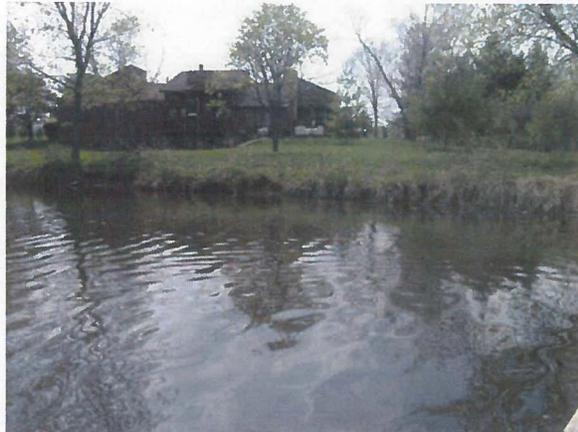
Figure 8: Shoreline erosion of Center Lake

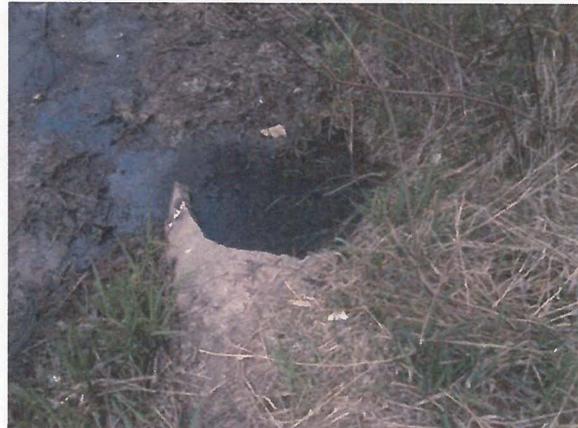
Figure 10: Outlet for Center Lake. This outlet was plugged during the April flood event.

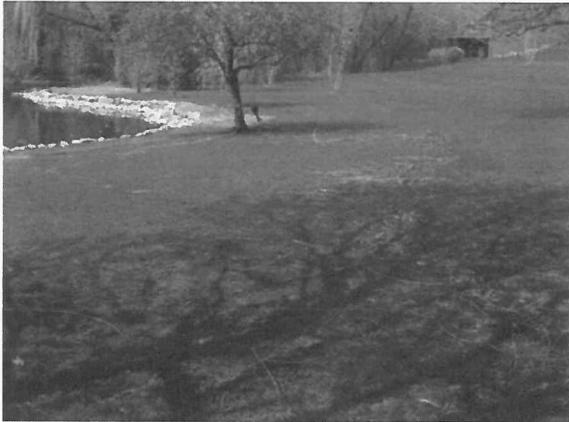
Figure 11: Debris line from recent flood between the West and Center Lakes.
